# Burn the over-voltage protection IC(NCP372) on XU4 on XU4

This guide is based on PCB REV 0.1 20150825.

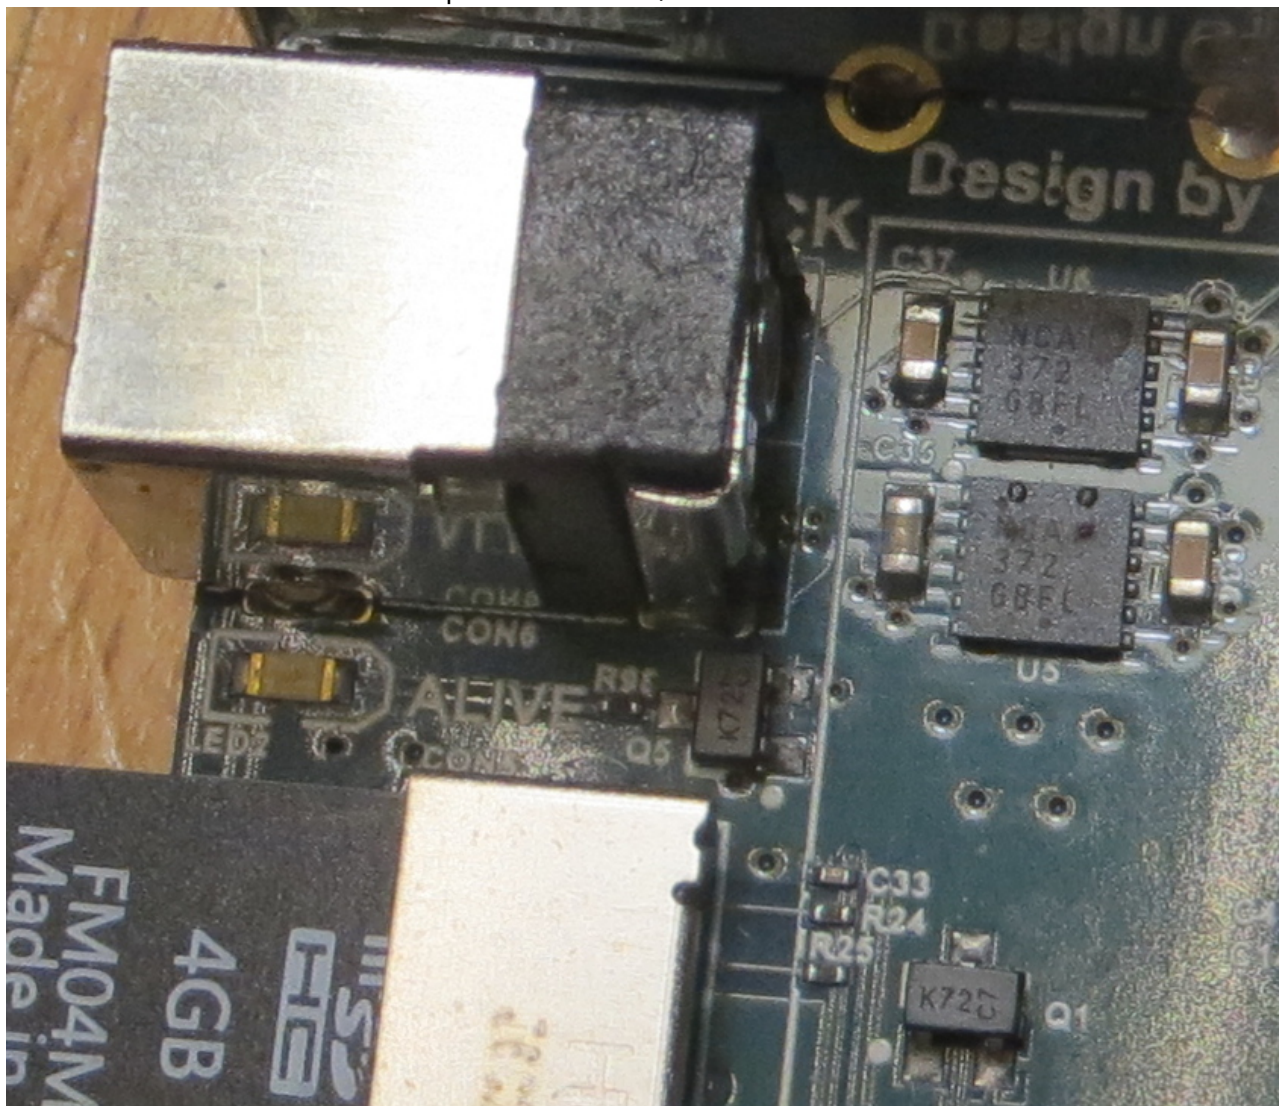
When you short circuit the 5V and GND pins of the shift shield or expansion connector, your odroid-xu4's over voltage protection IC can be blown up and there will be no red LED lighting. the U5 and U6 are that. [Reference - Schematics Page 2](#)  
You can easily solve this problem if you have a basic soldering skill.

1. Remove the heatsink. Check the protection IC U5/U6 surface. It seems to be fried.
