Burn the over-voltage protection IC(TPS259251) on XU4

This guide is based on PCB REV 0.1 20170912.

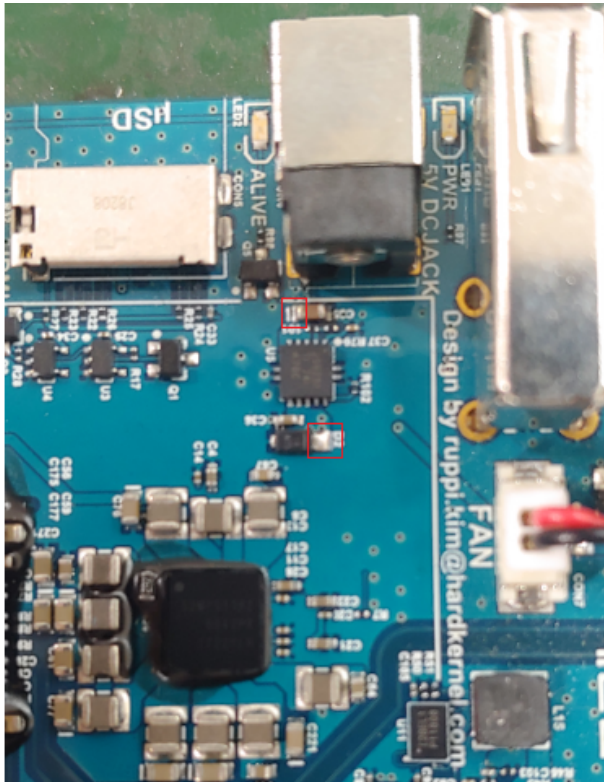
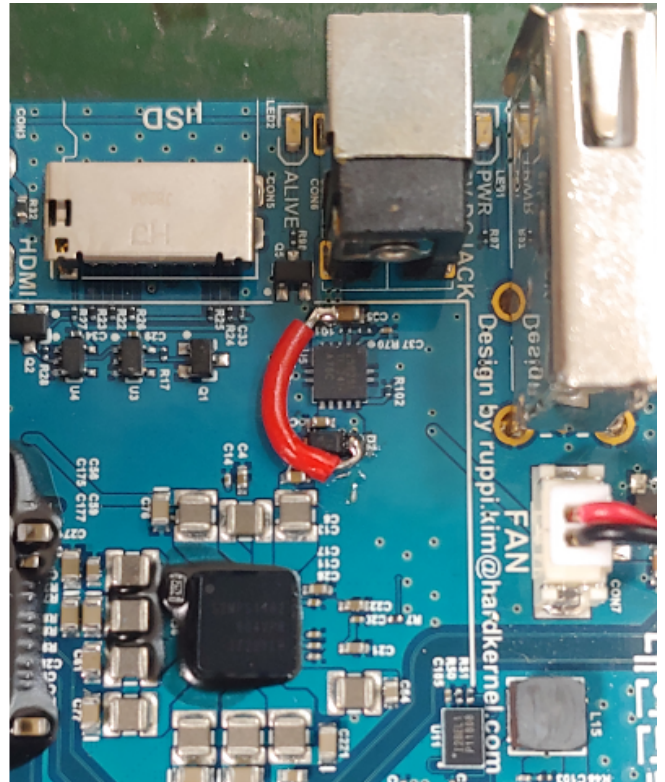
When you short circuit the 5V and GND pins of the shift shield or expansion connector, your odroid-xu4's over voltage protection IC can be blown up and there will be no red LED lighting. the U5 is that. [Reference - Schematics Page 3](#)

1. Remove the heatsink. Check the protection IC U5 surface. It seems to be fried.

2. Solder a wire from the 5V side of C296 to the 5V side of C36. these are the bypass capacitors of U5.
